All Fall Down: The Hartford Civic Center Roof Collapse

ENGR:2110:0B36 Statics

March 23, 2016

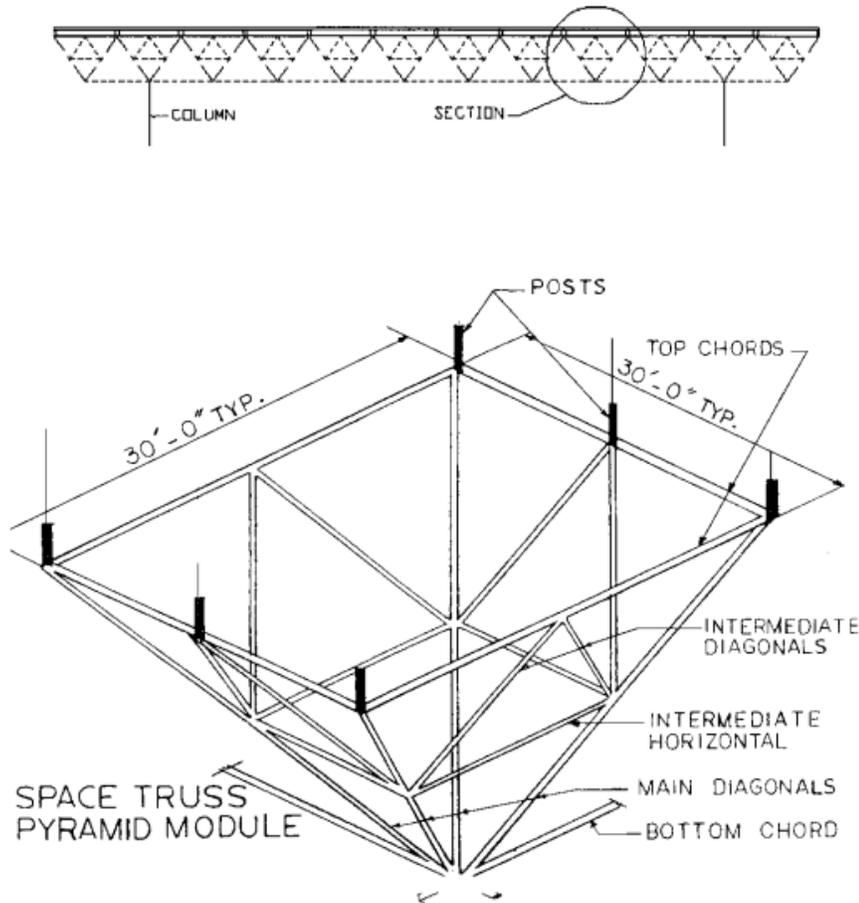
**Figure 1.** The space frame roof design consisted of two layers of steel bars connected by pyramidal trusses with the lower layer in cross formation (Martin & Delatte, 2001).

The roof structure was considered to be on the cutting edge of design, but several key flaws were present. The cross formation of the bottom layer was known to be incapable of carrying highly compressive loads and was prone to buckling. Compressive forces press down on the structure while tension forces act to pull the structure apart (Krishnamurthy, 2007). The usage of posts at each corner of the top layer of bars supported the roof but concentrated the weight at points instead of along the entire bar, increasing the pressure on the corners, or nodes. These initial structural errors, while serious, could have been corrected with careful calculations

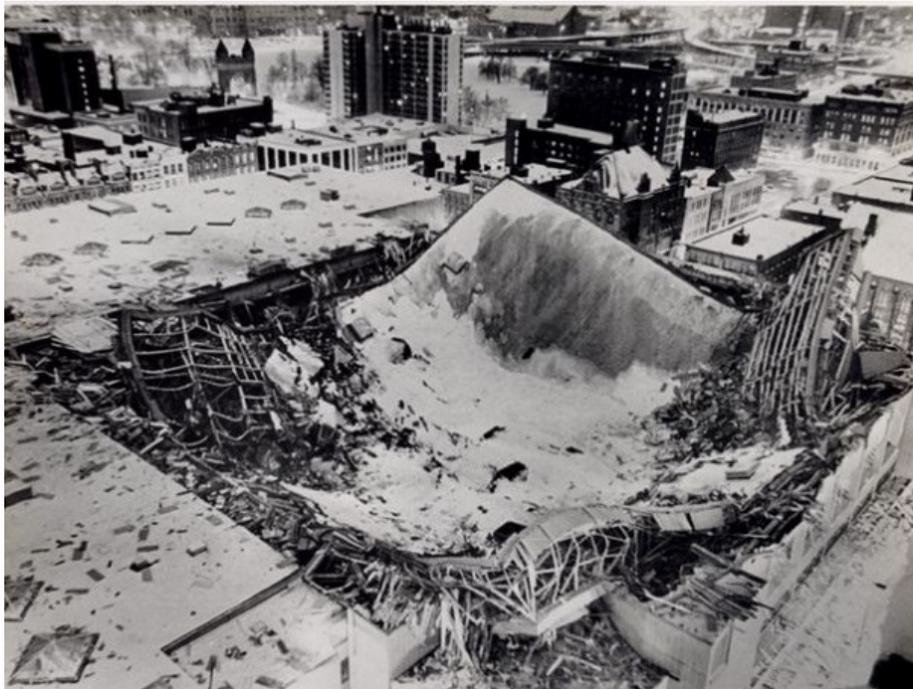
The city of Hartford appointed Lev Zetlin Associates to determine the causes of the roof collapse. The report listed the main causes as excessive overloading of the compressive forces on the top layer of the truss structure by as much as 852% (Krishnamurthy, 2007). The overloading was due to the corner connections being less braced due to the changes to the diagonal bracing

design during construction and several missing midpoint braces throughout the structure, as well as a low estimation of the actual weight of the roof. When the snowfall occurred, several overstressed beams on the top layer buckled, which changed the forces acting on the lower layer from tension to compression. The diagonal beams were unable to brace the structure and the roof collapsed. The Hartford Civic Center is shown on the day of the incident in Figure 2.

**Figure 2.** An aerial view of the Hartford Civic Center after the roof collapsed on January 18th, 1978 (Gammell, 2012).
