Autoroute 19 de la Concorde Overpass Structural and Ethical Failures

ENGR:2110:B35

April 27, 2016

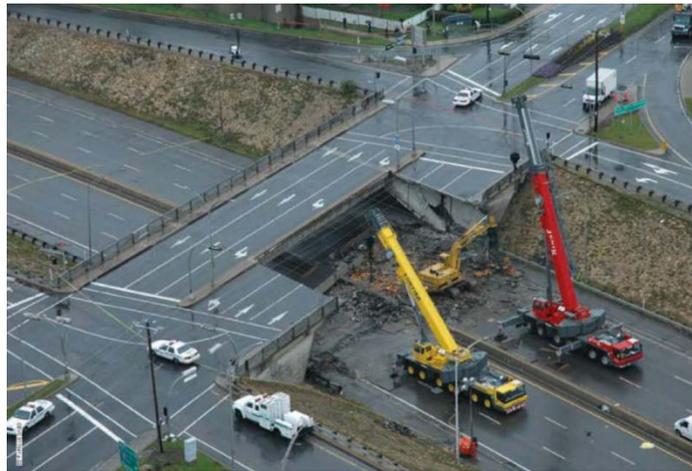
(Commission of Quebec, 2007)

During the afternoon of September 30, 2006, three lanes of the Concorde Overpass buckled onto six lanes of Quebec Autoroute 19. Unfortunately, this horrific incident claimed the lives of five people and critically injured six (“Canada Overpass Collapse”, n.d.). The collapse managed to completely crush two cars and sent three others and a motorcycle 20 feet below the overpass. However, surprisingly, the three westbound lanes remained intact. Analyses done before and after the collapse, make it clear that the deteriorated concrete and the lack of proper placement of supports led to the eventual downfall of the Concorde Overpass. This horrific situation could have been avoided if these failures were noticed at the times of regular inspection, or better regulations were laid out at the time of construction.

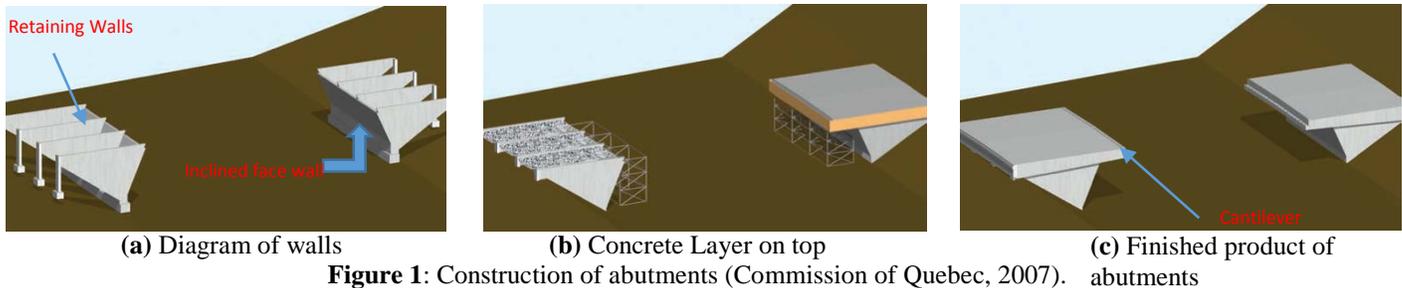
Figure 2: Moment and Force Pressures on Various areas of bridge (Commission of Quebec, 2007).

issues for the bridge, one must understand the main structure. The bridge was made up of two abutments, as shown in the three components of Figure 1, which are supporting walls at the sides of the overpass. Each abutment consisted of an inclined wall and four retaining walls. The latter had a thick layer of concrete, some of which extended over the inclined face, forming a cantilever.

A bending moment is the result of the forces on a section causing it to rotate about a point or bend inwards. A shear force is the forces in play within beams to balance an external load (“Analysis of Beams Shear Force and Bending Moment Diagram”, n.d.). Figure 2(a), shown on the bottom left, shows the bending moment, and 2(b) on the right shows the shear force under the pressure of a dead load, or the weight of all of the structural components. The darker red/pink areas in figures 2(a) and 2(b) below indicate the greater force. This additional force was mainly due to the sidewalks, which created stress at the edges of the cantilever. It was concluded from this stress analysis that additional reinforcement would be needed to counteract the load that would be present on the cantilever portion of the overpass. This added support could have come in the form of vertical bars anchored to the top and bottom of the cantilever slab (Commission of Quebec, 2007).

During the construction of the de la Concorde, the designers assumed that there was an equal load distribution over the entire overpass. This analysis was done using a unit slice of overpass that was assumed to be representative of the entire structure. Hence, engineers did not realize the effects of the structure being skewed at the southeast and northwest corners of the abutments. This was an error that could have been caught by way of the regular inspection. This skew created sharp stress concentrations at the corners of the cantilevers. Since this skew was underestimated at the time of construction, the load concentrations were not accurately calculated (Commission of Quebec, 2007). This concept can be understood by a simple force analysis. The load on the overpass is distributed over the various portions of the bridge, but, not equally. Hence, the force acting down on the edges of the overpass could not be counteracted by the normal force, or the force acting on the load by the bridge in the cantilever region. This can be compared to a simple wood table that cannot sustain the weight of everyday objects being placed upon it due to improper construction.

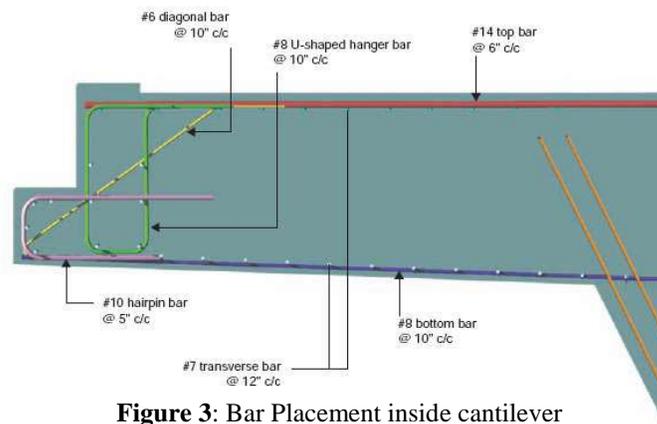
Figure 3: Bar Placement inside cantilever (Commission of Quebec, 2007)

Another major issue could be attributed to the specific bars placed within the cantilever. For example, the #8 and #6 bars were not properly anchored to the top bar (see Figure 3). This faulty anchoring created a weak zone that could not handle a large load, as described previously (Commission of Quebec, 2007). This error, though it may seem small, effected the daily use of the bridge.
