Big Blue Crane Collapse  
Solaris Nite  
Engr Fund I: Statics  
AAA/A32  
Prof. Raghavan  
12/1/15

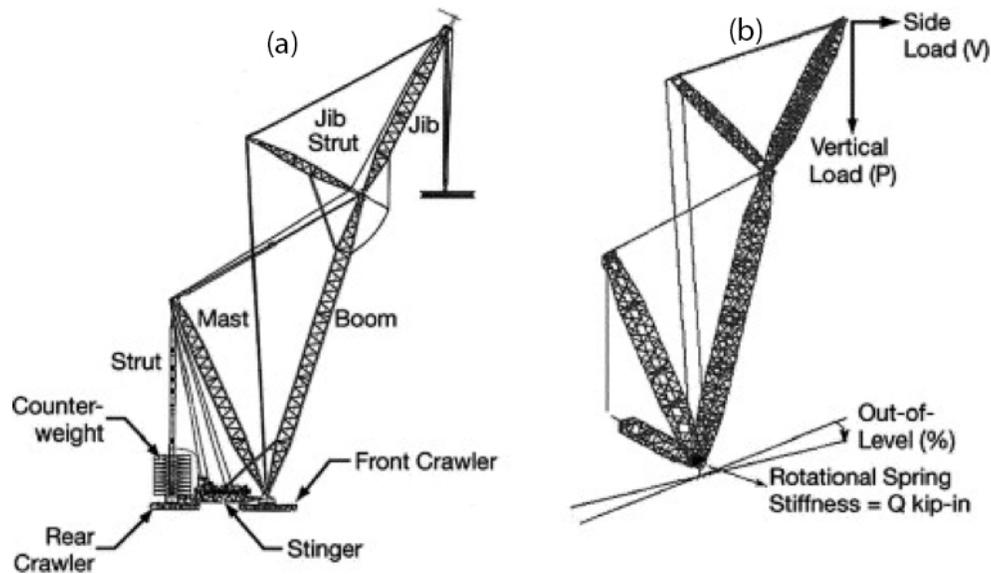
The physical concepts that came into play that day are really quite simple. There were two main shortcomings that caused the incident. The most fundamental concept that construction cranes employ is equilibrium. A physical object is in equilibrium when all the forces acting on it sum to zero in every direction. We see equilibrium everywhere. One simple example of an object in equilibrium is a person standing on the ground. Gravity has an effect on that person's mass causing a force downward while the ground underneath him pushes with an equal and opposite force upward. As a result, we say that this person is in static equilibrium because they are not accelerating in any direction. When designing a crane, it is the job of the engineer to create a machine that can maintain equilibrium with varying load weights at different arm distances from the crane's operating hub. On this particular crane, a 1150 ton counter weight was used to offset the load weight on the opposite side of the hub (Figure 1a).

Figure 1a & 1b - Big Blue Crane components diagrams. (Ross, 2007)

The load lifted that day had a lot of surface area facing the wind. Loads like this are called “sail loads” because they cause a large additional force in the direction of the wind. It is named this because, like a sail, it has a lot of surface area for the wind to catch. Lampson specified that the crane can only withstand a side load that is two percent of the total weight being lifted. A side load is any force that acts in the direction perpendicular to the lift—in this case, wind (Figure 1b).

The large force of wind on the roof piece created a side load far surpassing the 2% maximum. It is that sideways force that was the primary cause for the crane collapse and the reason for the warning stated in Lampson’s crane specifications. This force caused the carefully balanced crane to fall out of equilibrium. As a result, the connection where the “Boom” and “Mast” met the “Front Crawler,” (Figure 1a), began to bend, leading to an even greater break in equilibrium as the weight-forces shifted out of their carefully balanced locations. At this point, the entire crane pulled itself over, cascading as its individual pieces fell out of equilibrium, pulling its connected pieces with it.
