I-35W Highway Bridge Collapse

ENGR:2110:0A31 Engineering Fundamentals I: Statics

University of Iowa College of Engineering

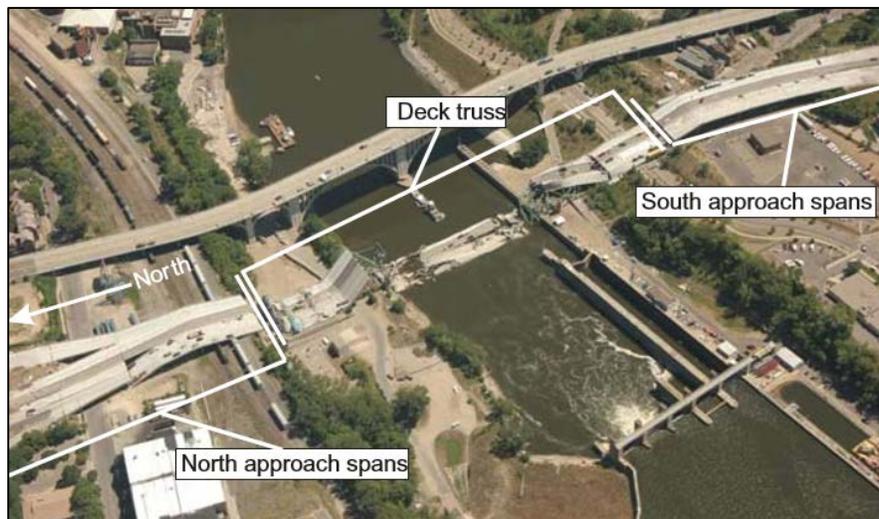
On the fateful evening of Wednesday, August 1st, 2007, the interstate highway bridge I-35W over the Mississippi River in Minneapolis, Minnesota catastrophically failed resulting in 13 deaths and 145 injuries (National Transportation Safety Board, 2007). In the aftermath, Figure 1 shows that nearly 1,000 feet of the 1,907 foot-long bridge (deck truss) collapsed with nearly 50 percent of that portion (458ft) falling into the river (National Transportation Safety Board, 2007). After the bridge's collapse, the subsequent investigation that was conducted by the National Transportation Safety Board (NTSB) would go on to detail a long-standing history of negligent maintenance performance by the bridge's developer and overall disregard by federal and state authorities to proactively address the concerns of what many engineers expressed. In addition to the substantial list of ethical lapses that contributed to this disaster, the design firm expressed considerable shortsightedness in the final design of the bridge, which if addressed properly, could have prevented a failure of this magnitude.

Figure 1: Aerial view of the I-35W Bridge after the collapse
(National Transportation Safety Board, 2007)

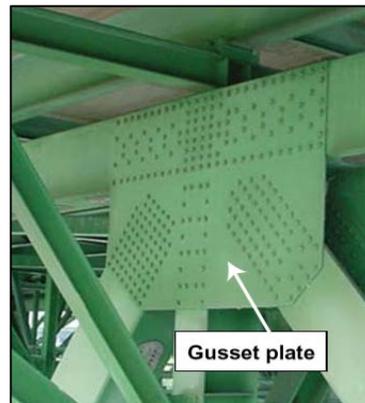
Figure 3: Actual Gusset Plate from I-35W Bridge
(National Transportation Safety Board, 2007)

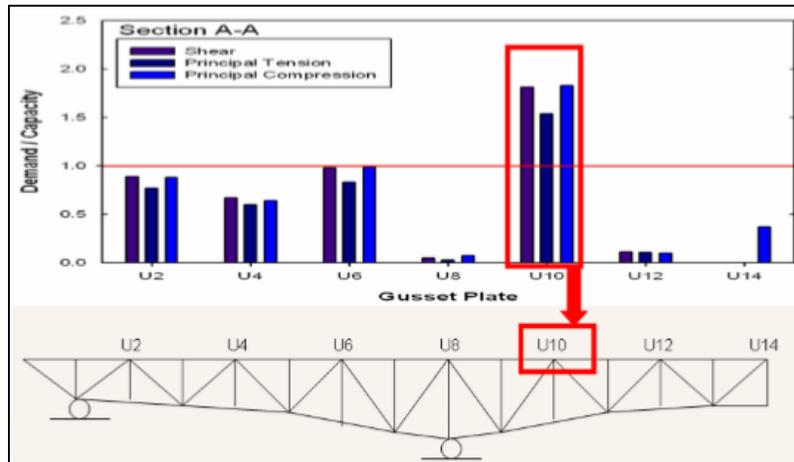
After an extensive investigation of the bridge’s failure, the NTSB concluded that the collapse of the I-35W Bridge was the result of design errors made by the consulting firm in the gusset plate at the U10 position (seen in Figure 4). The thickness of the U10 gusset plate was

Figure 4: Bridge Capacity/Demand with respect to each Gusset Plate (Holt & Hartmann, 2008)

The conclusion from Figure 4 is quite simple to understand. By focusing on the U10 gusset plate (highlighted in red), it is obvious that the force on the bridge (demand) was far greater than the capacity for which it was built to handle. This is clearly seen by the indication of the maximum demand to capacity ratio indicated by the solid red horizontal line. On the day of the collapse, several pieces of construction equipment and aggregate (crushed rock, sand or gravel) were brought onto the bridge and positioned directly above the U10 gusset plate in attempt to resurface the bridge deck (road surface). As the NTSB would later report, the appropriate placement of construction loads on the bridge during repair or maintenance activities was never discussed due in large part to a severe lack of guidance between bridge officials

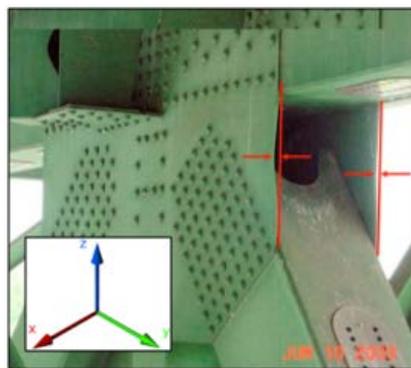
According to Figure 5, there is indisputable evidence that the U10 gusset plate was experiencing such an excessive force in the downward (z)-direction that it had actually began to bow outward prior to the collapse. The subsequent upward force in the (z)-direction of the bridge was not nearly enough to keep the bridge in equilibrium, resulting in catastrophic failure. For convenience, a red line was added to indicate the original position of the plate if it had been properly designed in accordance with Newton's third law.

Figure 5: Bowing of Gusset Plate U10 Prior to Collapse
(Hao, 2010)
