Lessons from Loma Prieta

Megan Helms

Statics:2110:0A33

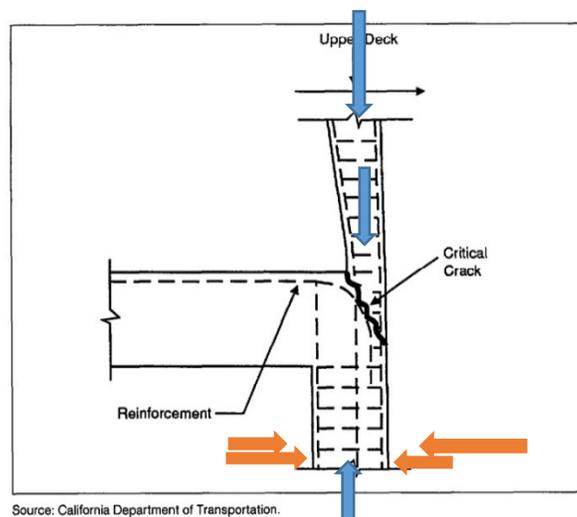
Figure 2. A side view of one column of the viaduct. Forces in blue represent the weight of the deck and the normal force from the ground--these are present in normal conditions. Forces in orange represent abnormal forces that occurred due to the earthquake, which resulted in a shear force along the indicated crack (United States, 1990).

failed to notice how the structure and connection of these columns resulted in a shear force along the angle in Figure 2. Shear forces, like tension or compression forces, result when two forces oppose each other but do not point directly at one other. If the object in shear can be moved, this results in sliding motion as the forces push past one another. The Cypress street viaduct demonstrated this during the Loma Prieta earthquake as the extreme shaking of the ground put numerous, varying forces all along the base of each column of the viaduct. These forces were amplified by what was known to be very soft ground underneath the structure, worsening the shaking undergone by as much as five times (James, 2006). These forces broke the concrete surrounding the connecting pins between columns, and shook the base column so that it was slightly farther from the upper column. This put the upward and downward forces that had always been present in shear, and they were then strong enough to crack the columns. The columns slid out from under the upper deck, resulting in the collapse of over one mile of the entire viaduct (see Figure 3).

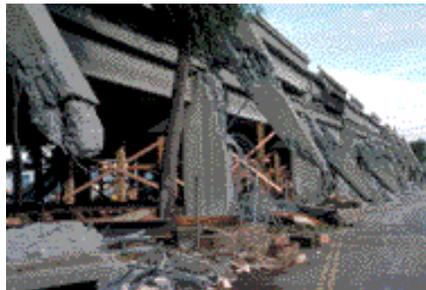
Figure 3. A side view of the collapse viaduct. The cracking from the shear force diagonally between columns can be clearly seen (Wilshire, 1999).
