On August 1st, 2007, one of the busiest bridge roads in Minneapolis, Minnesota collapsed, and the middle section of the bridge fell into the river, which caused 111 cars on the bridge to drop into the river from the broken bridge. Thirteen people died and 145 people were injured from the accident (National Transportation Safety Board, 2007). This great disaster caused shock all over America and warned, not only engineers, but also people from all career areas. This accident was a tragedy from which we can learn important engineering lessons. We need to learn from this event to prevent us from repeating the same mistake of sacrificing quality work for a lower cost.

After the investigation, the National Transportation Safety Board came to a conclusion that it was the original bridge design that caused the tragedy (National Transportation Safety Board, 2007). They pointed that the gusset plate, which is a thick metal plate that

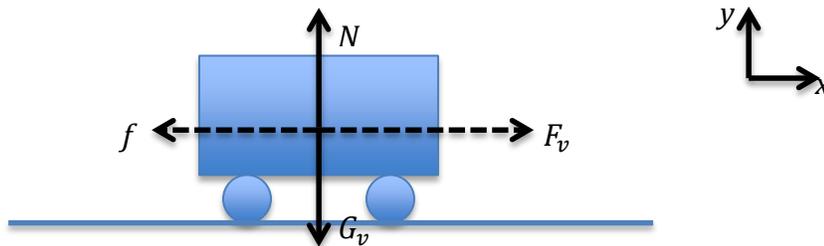
Figure 1: the free body diagram of the force acting on one vehicle

In this analysis, only the vertical forces, the y components, are taken into consideration. In order to keep the bridge in a stable state, all forces in the y direction need to be equivalent. As a result, the force that the vehicles act on the bridge should equal to the normal force of the bridge. And when the weight of the vehicles is bigger than the normal force the bridge can support, the bridge will collapse.

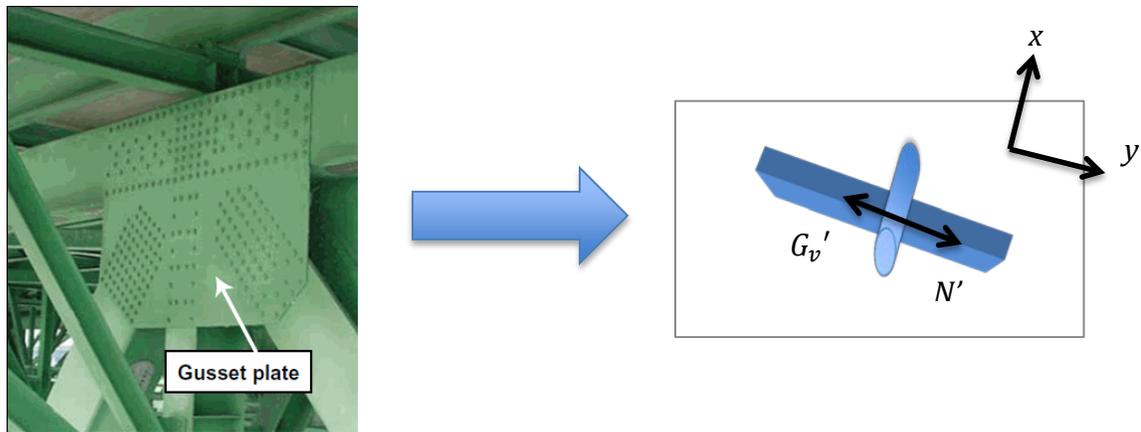
For this particular case, the bridge collapsed because the gusset plate was too thin to hold the weight of the bridge and weight of cars on the bridge. As shown in Figure 2, the pin was subjected to too much pressure from the weight of the bridge and the cars, causing the pin to split into two parts. Without the support of the pin, the gusset plate was bent and could no longer support the extra weight of cars and the bridge that used to be supported by that pin, and the weight being supported was applied to the rest of the bridge, which caused the bridge to fail.

Figure 2: the gusset plate of the old Minneapolis I-35W Bridge
(National Transportation Safety Board, 2007)
And the side view of the plate and one of the pins

Similar to the analysis above, only the forces on the y component are taken into account since the perpendicular forces on the x component have nothing to do with the plate. The force G_v is distributed to several small pins on the gusset plate. Suppose that the force that each pin applies to the gusset plate is G_v' and the force that the gusset plate applies to the pin is N . In this case, the pressure that the plate withstands is equal to the force G_v'

divided by the contact surface area between the plate and the pin (call it S). If the engineers who designed this bridge had chosen a thicker plate, which would mean that the area S would become larger, it could have resulted in less pressure acting on the plates with the same force and a big disaster might have been avoided.

Alternately, if the engineers had chosen a larger gusset plate so that more pins could distribute the total force G_v so that G'_v became smaller, the tragedy might have been avoided. In this case, when computing the pressure exerted on the gusset plate, G'_v divided by the contact surface area S , the pressure becomes smaller, and this pressure might have been small enough to be held by the gusset plate. Another possibility that could have avoided this failure would have been if the design engineer had chosen another different but more solid material for the pin. In this case, though the pin would still have the same relatively big pressure from the gusset plate, by using a more solid pin, the pin would be strong enough to hold the big pressure from the gusset plate. Any of these improvements could have been made to save thirteen lives.
