Lessons from Loma Prieta

Megan Helms

Statics:2110:0A33

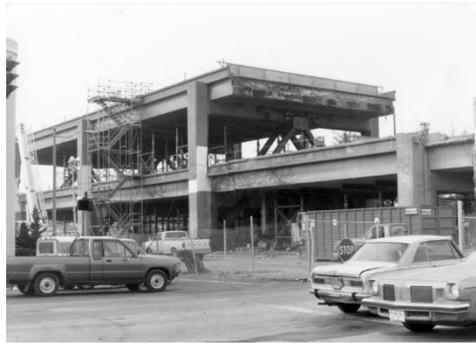
Figure 1. Construction of a test section of the Cypress Street Viaduct: the two bridge decks are supported by concrete columns attached to one another at the first deck level (Merport, 2007).

Construction on the Cypress Street viaduct (see Figure 1) was completed in 1957, with engineers meeting the most up-to-date earthquake safety criteria of the time. Unfortunately, earthquake standards changed dramatically after a devastating earthquake in 1971 caused the collapse of five California bridges. Such major damage prompted a re-evaluation of bridge and other column designs, culminating with a three-step reinforcement procedure for all structures built before 1971, including the Cypress Street viaduct. Phase one of reinforcement involved strengthening the connection between all deck sections, and was seen as both the most important
